Minerals Inspection Report

Report Date: 11/18/2013

Mine Name: Asphalt Ridge	Permit Number: M/047/0032	Mine Status: Inactive
Operator Name: Tar Sands Holdings II, LLC	Inspection Date: 11/18/2013	Permit Fees: Delinquent
Inspector(s): April Abate	Inspection Time: 2:00 PM	Bond Amount: \$302,000
Attendee(s): Rick and Annette from Asphalt Ridge	Weather: Clear, 55 F	Bond Escalation: Due
Inspection Purpose: Routine inspection		Prior Inspection: 05/18/2011

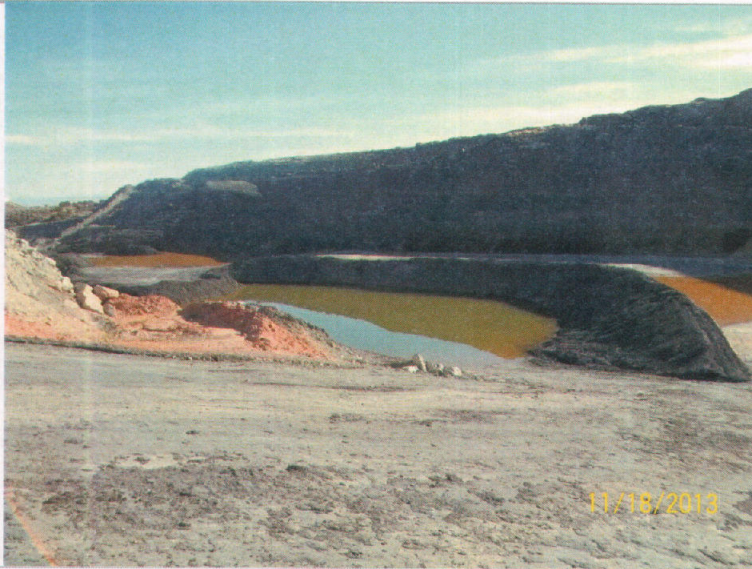
View of the high wall looking south.

6. <i>Reclamation</i>	<input type="checkbox"/>	<input type="checkbox"/>
7. <i>Backfilling/Grading (trenches, pits, roads, highwalls, shafts)</i>	<input checked="" type="checkbox"/>	<input type="checkbox"/>
The seep noted on the highwall was fairly large in size. It would be prudent to have a geotechnical engineer evaluate it for stability to ensure that no failures occur.

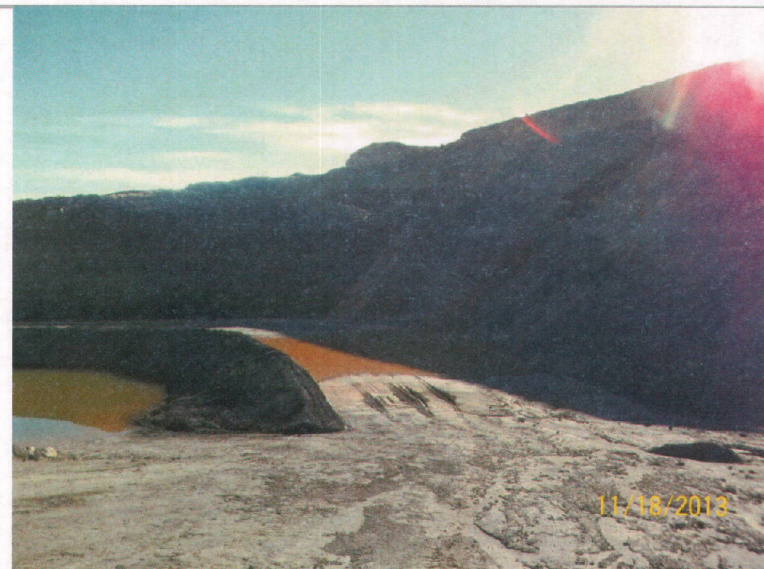
3. <i>Protection of Drainages/Erosion Control</i>	<input checked="" type="checkbox"/>	<input type="checkbox"/>
Several drainage issues were identified at the site. A seep identified on the west highwall was observed generating a large pool of standing water on the haul road at the base of the pit. Two smaller seeps were identified on the north side of the pit on south facing slopes near the base. At one of the seeps, flowing water was observed. This seep has been labeled on the plan maps. Yellow and red staining was observed from both seeps. Drainage problems were identified at the base of the seeps. Water was not draining properly to the groundwater collection area (near MW-2) leaving a blocked off canal of standing water. Two storm water ponds and MW-1 and MW-2 were located during the inspection. Personnel at the mine were not aware of the last time the monitoring wells were sampled. Drainage from the haul road was flowing down a dirt road that leads to the southeast property gate. Erosion rills were noted along this dirt road and a large splay of sediment was dumped at the bottom of a low spot depression (this depression) did not appear to be one of the designated sediment ponds. Discussed with mine personnel adding berms along the road to prevent sediment from eroding into this area.

View of the high wall facing southwest. A seep originates (below the sun) to the right of the photo. Standing water from the seep is seen on the haul road.

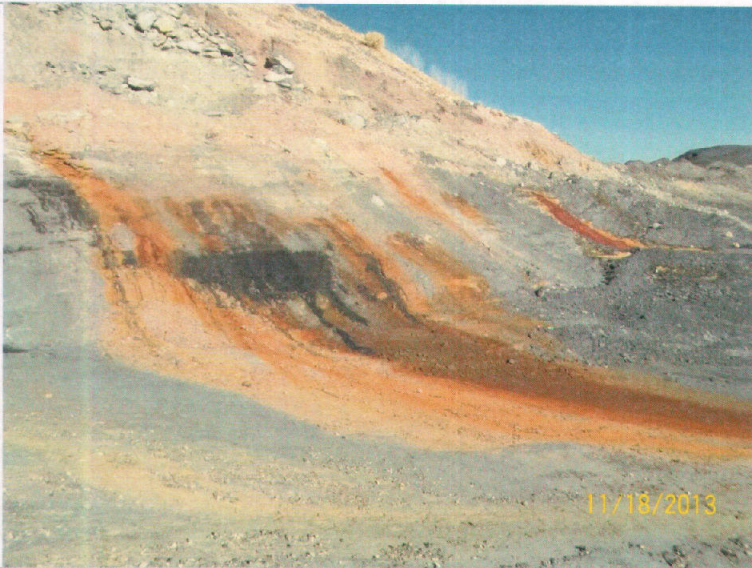
A small seep was noted on the north high wall of the pit.

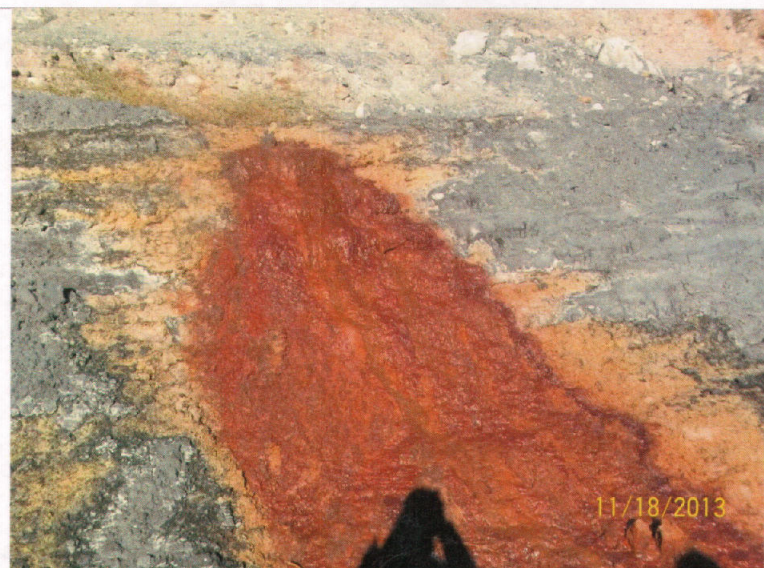
A second seep from the north highwall was noted showing significant iron staining. This seep is labeled on the mine plan maps.

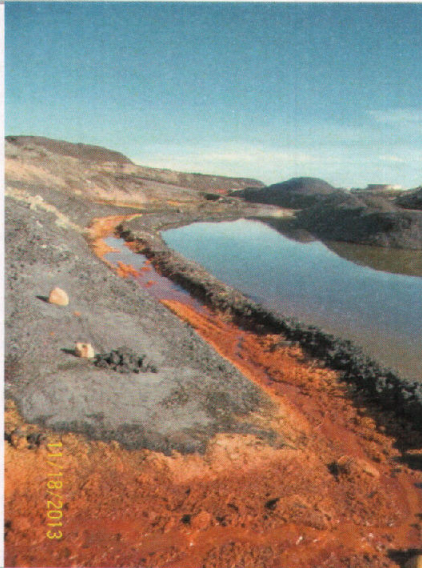
Water flowing from the seep along the north high wall was forming a canal and not draining properly to the impoundment

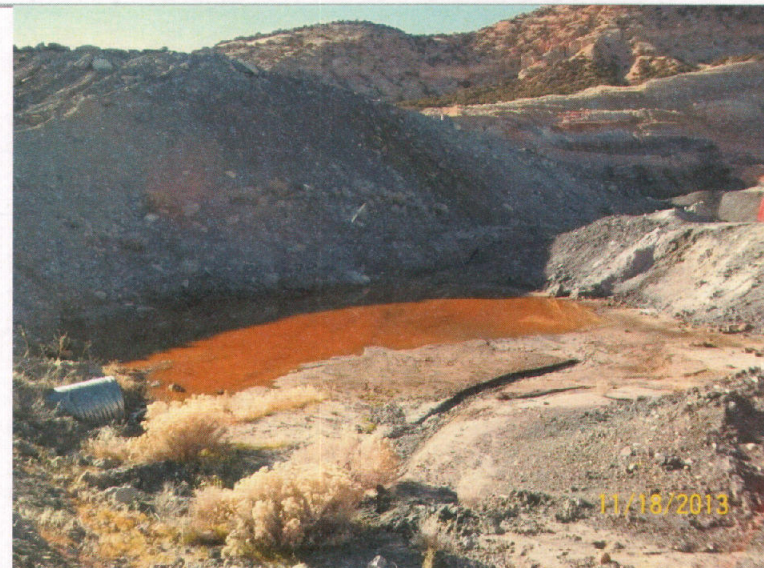
A sediment pond was noted adjacent to monitoring well MW-2.

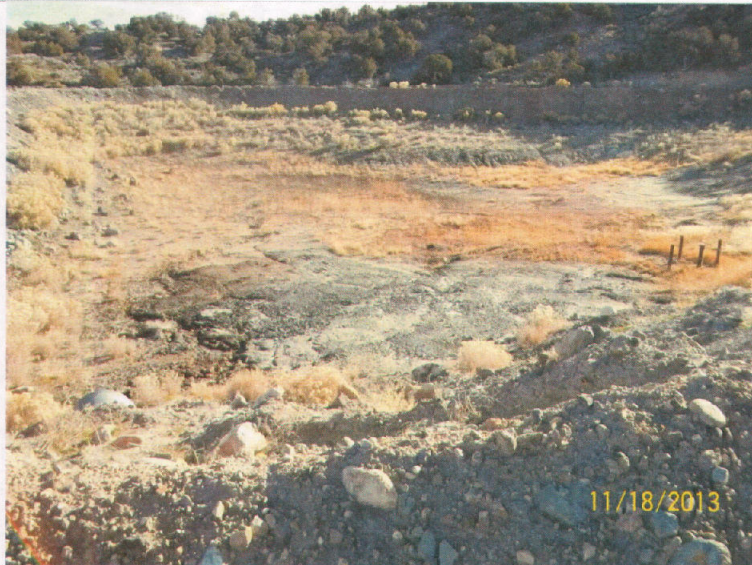
A second sediment pond was noted south of the first impoundment and connected by a culvert running under the haul road.

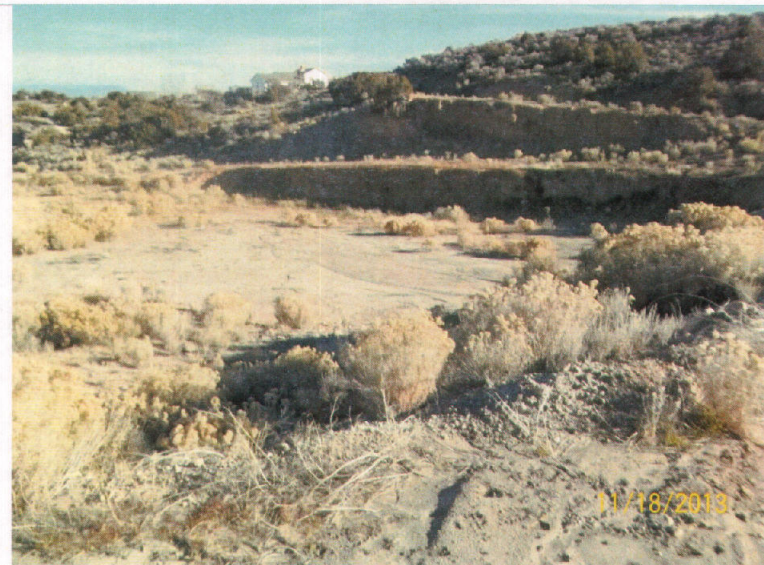
This area represents the boundary between the haul road and the access gate into the property. A large splay of sediment was noted due to unbermed areas.

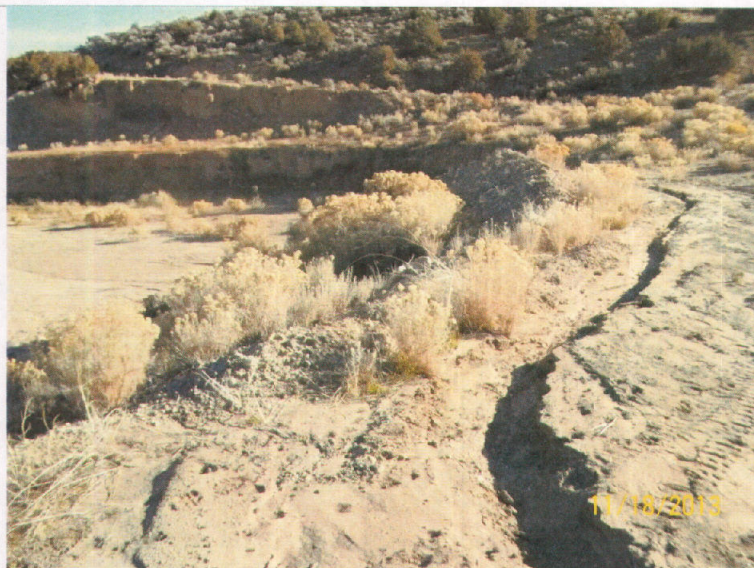
An area of heavy erosion was noted in the southeast corner of the site. No berms were in place to control sediment from migrating into this depression.

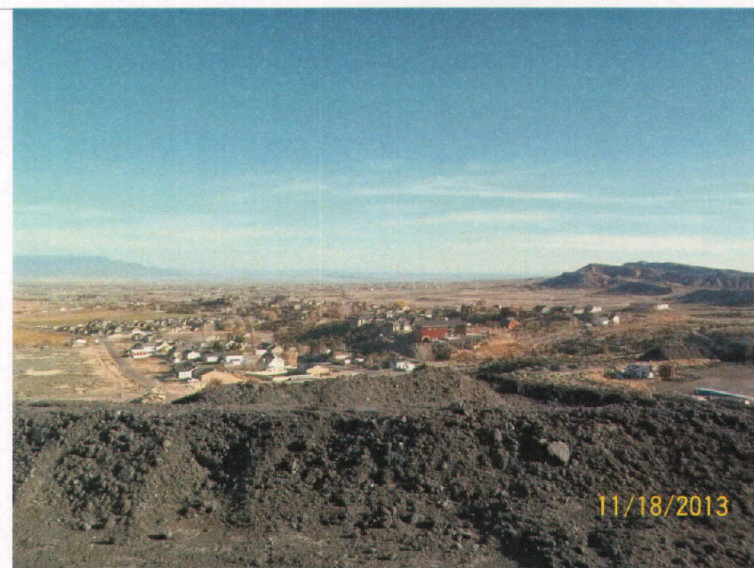
View east of the residential neighborhood directly below the mine.
